Lubemaster Bluescope Steel Case Study

Company: **NCH Australia Pty Ltd**
Address: **7-9 Ralph St, Alexandria, NSW**
Application: **HSM Steel Manufacturing**
Country: **Australia**

Bluescope Steel Hot Strip Mill Walking Beam Furnace

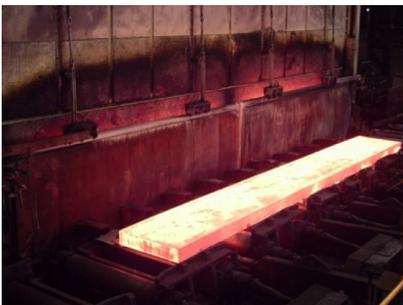
The discharge table rolls are affected by extreme temperatures because of their close proximity to the discharge doors of the furnace. The furnace internal temperature is 1280°C and when the doors open to extract a slab out of the furnace, the table roll bearings, associated lubrication lines and hoses are exposed to these high temperatures.

Hot Steel Slab Exiting the Furnace

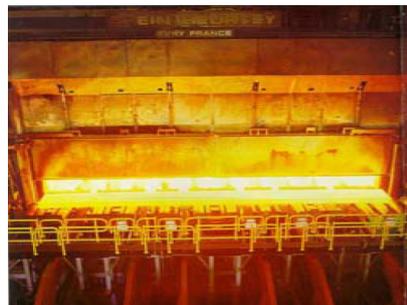
Walking Beam Furnace Opening
